**CORROSION TESTS OF LITHIUM FLUORIDE
IN CONTACT WITH COLUMBIUM ALLOYS**

TOPICAL REPORT II

LITHIUM FLUORIDE BELLOWS CAPSULE TESTS

January 29, 1970

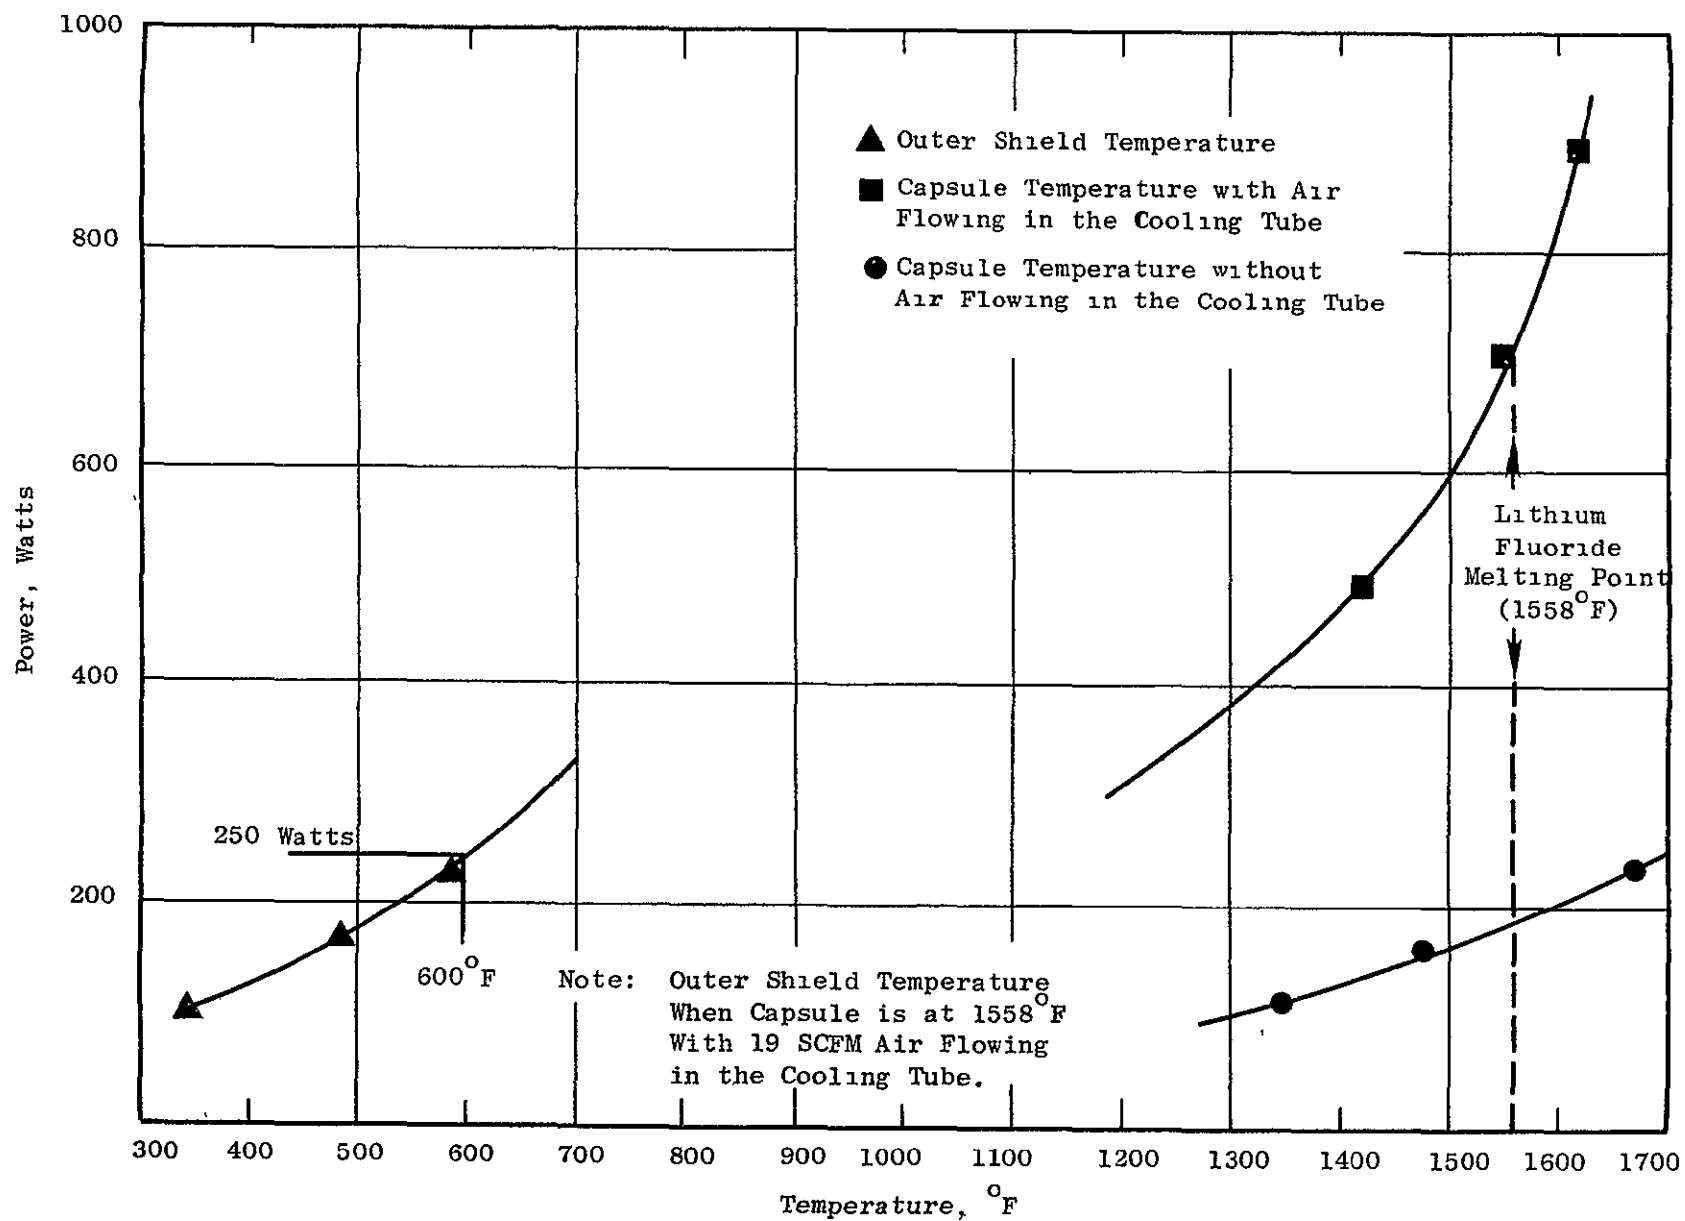
Figure 32. The Steady State Temperature Power Measurements - Lithium Fluoride Bellows Capsule Test II.

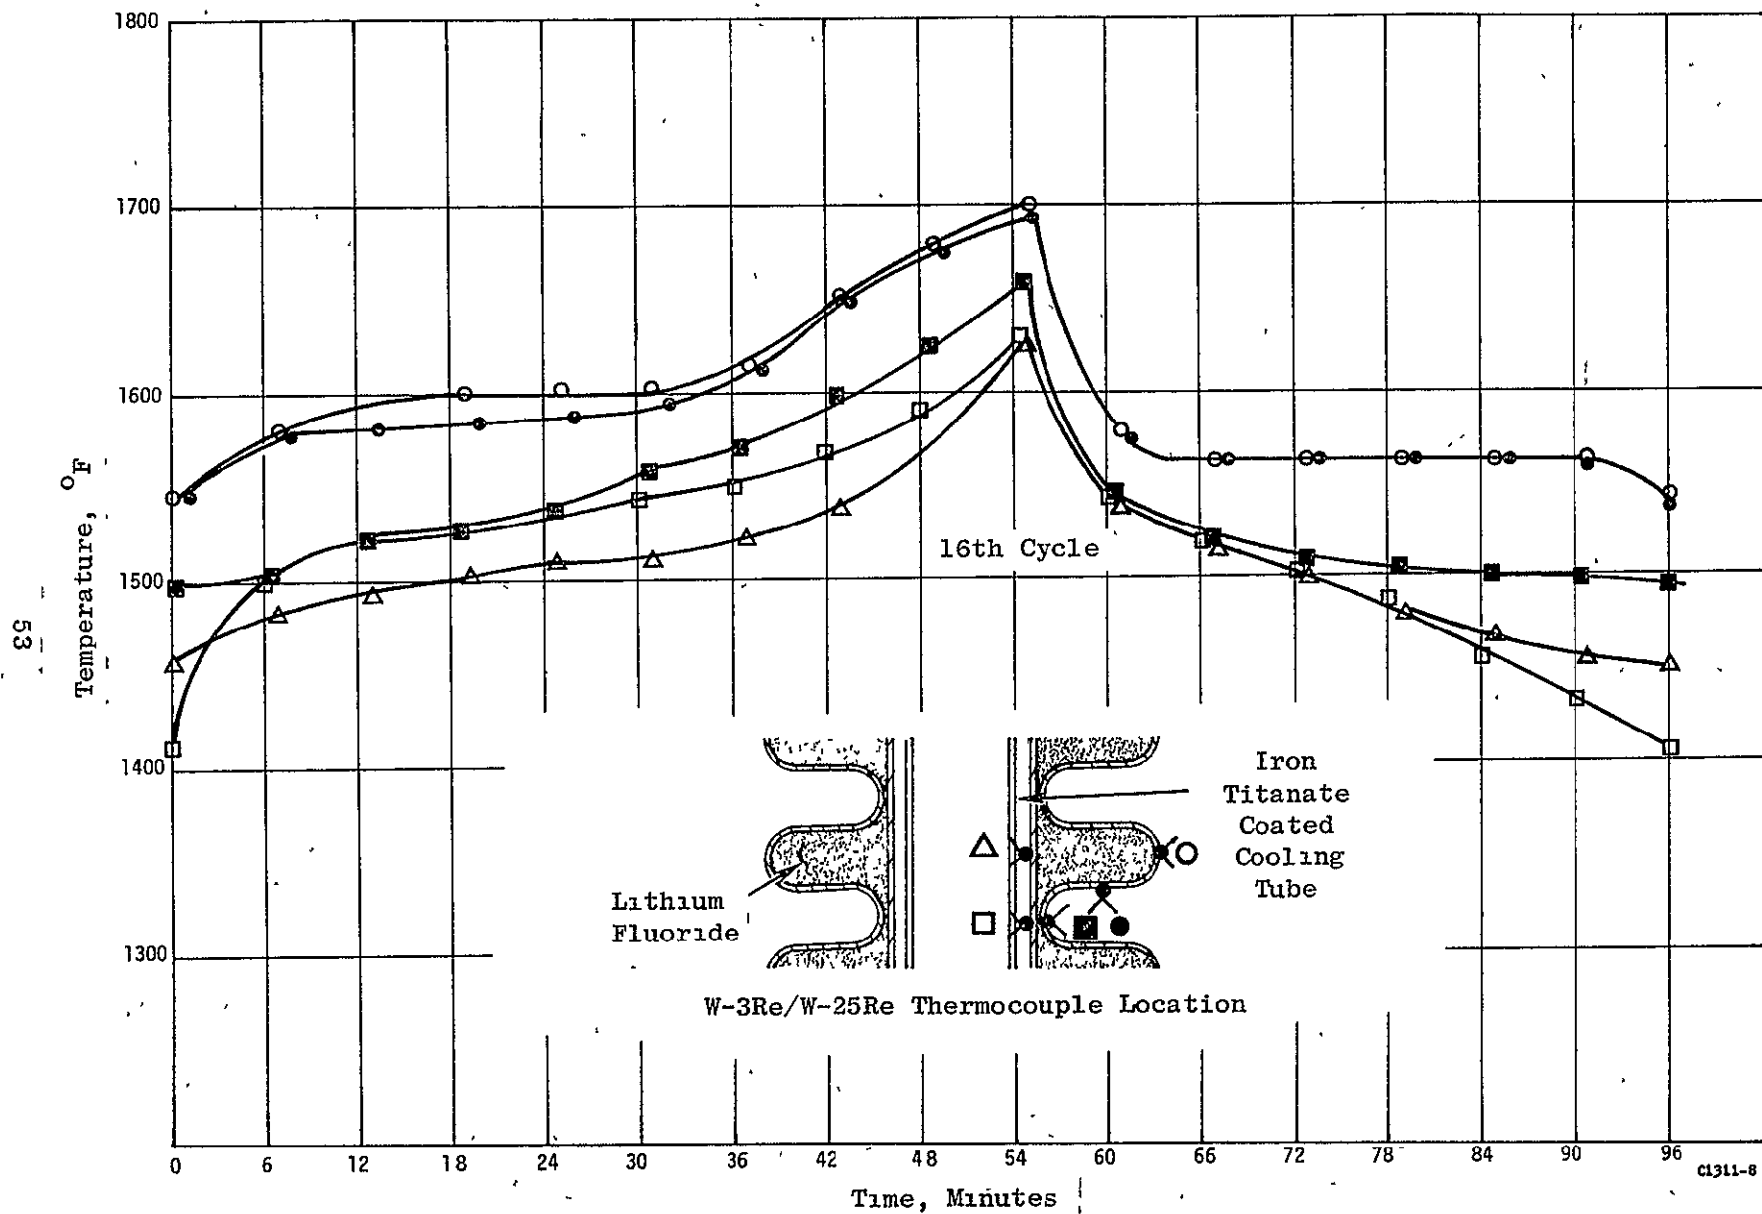
Figure 33. Temperature Profiles on the 16th Cycle of the Lithium Fluoride Bellows Capsule Test II.

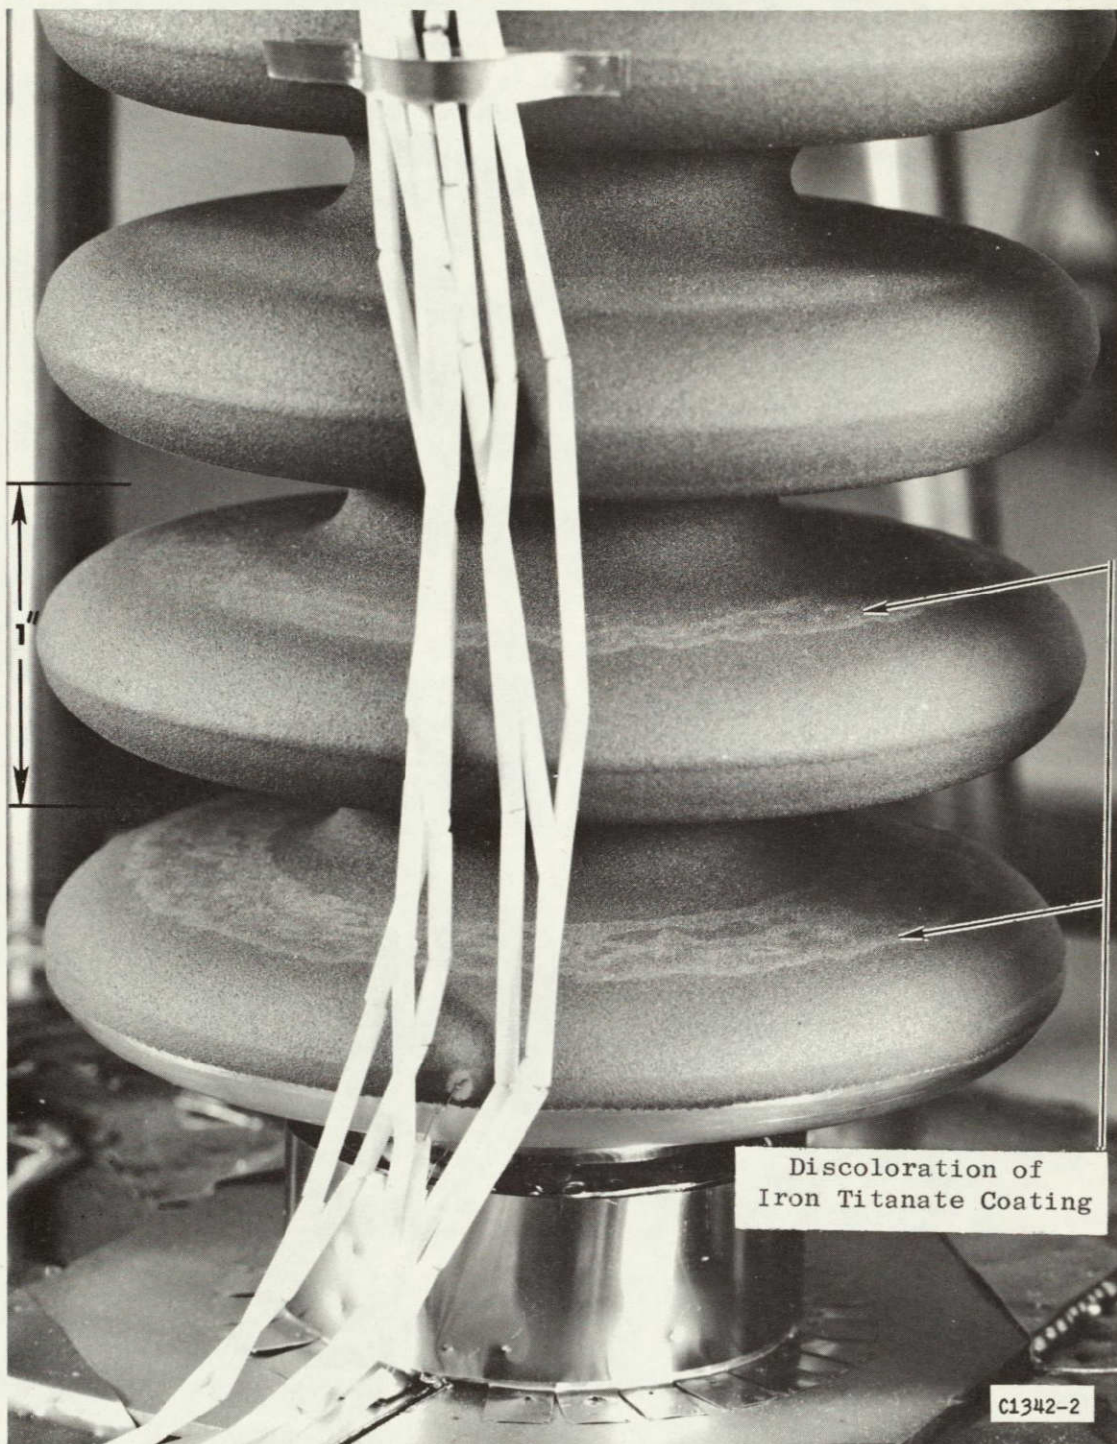
Figure 34. Bottom Convolutions of Lithium Fluoride Bellows Capsule II Following 1000 Hours of Testing Showing Discoloration of the Coating. The Capsule was Cycled Between 1550°F and 1700°F. (C67121173)

Visual inspection of the capsule after 1000 hours test time revealed no significant change in the capsule. Some discoloration of the iron titanate coating was noted on the bottom two convolutions as shown in Figure 34; however the coating's adherence did not seem affected and no significant changes in capsule dimensions were noted.

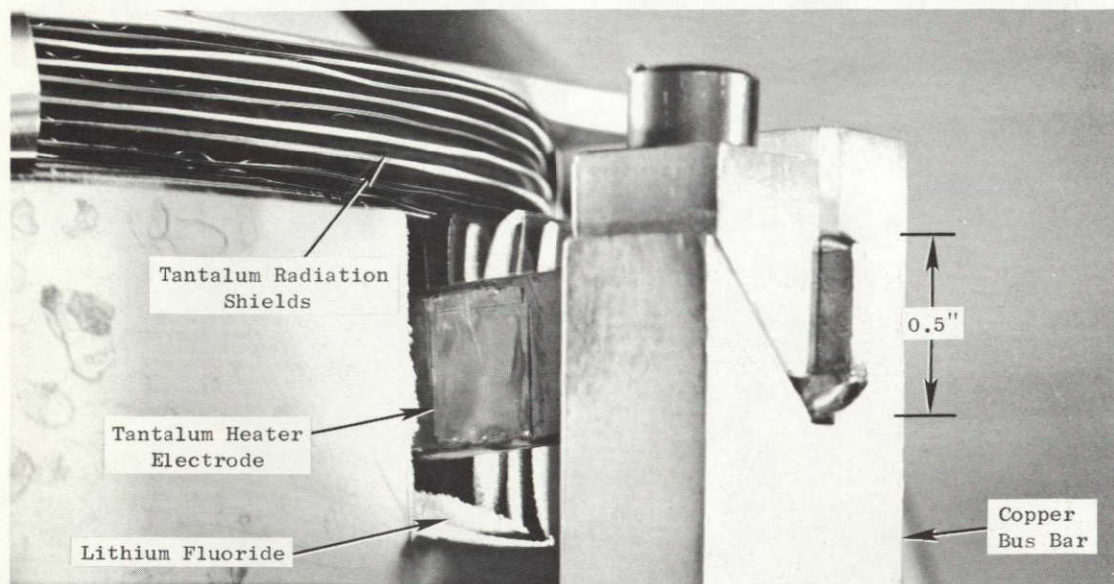
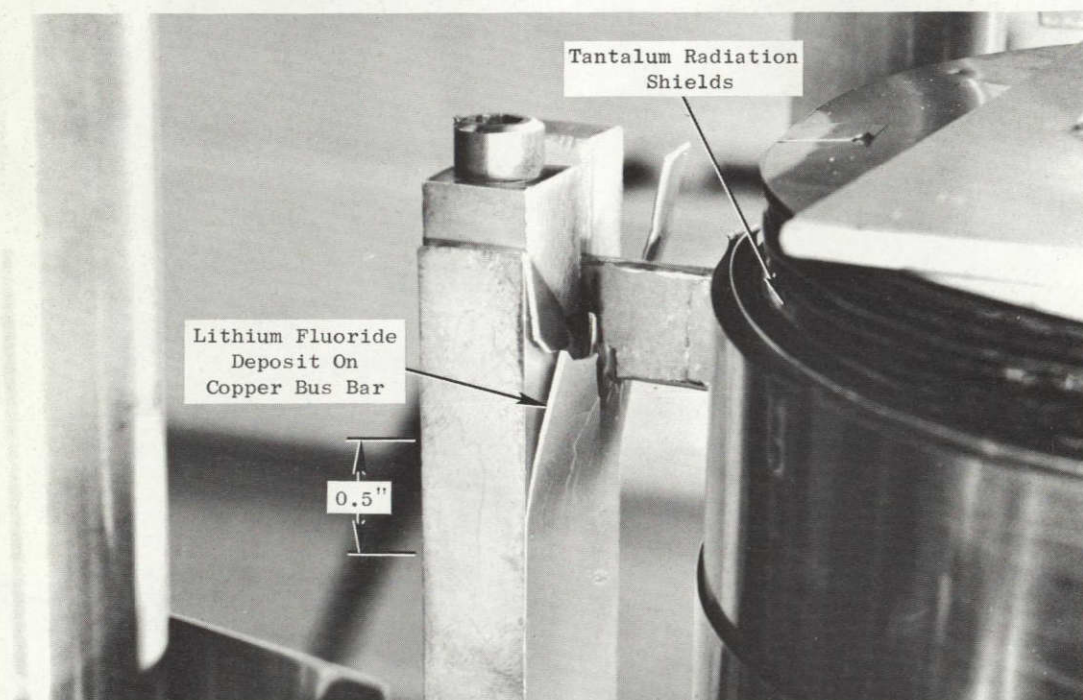
Figure 35. Lithium Fluoride Bellows Capsule II Test Facility After 3000 Hours of Testing Showing Lithium Fluoride Deposits on Copper Bus Bars and Tantalum Radiation Shields. (69031980 & C68031830)

Visual examination of the test assembly, following removal of the vacuum chamber bell jar, after 3000 hours test time revealed a deposit of lithium fluoride on the tantalum radiation shields and the copper bus bars as illustrated in Figure 35. Additional lithium fluoride deposits were found on the cooling tube and thermocouple insulators following removal of the tantalum shielding as shown in Figures 36 and 37. Visual inspection of the capsule itself did not indicate any significant changes in shape or appearance as can be seen in Figure 38. The capsule was removed from the test facility and examination continued.

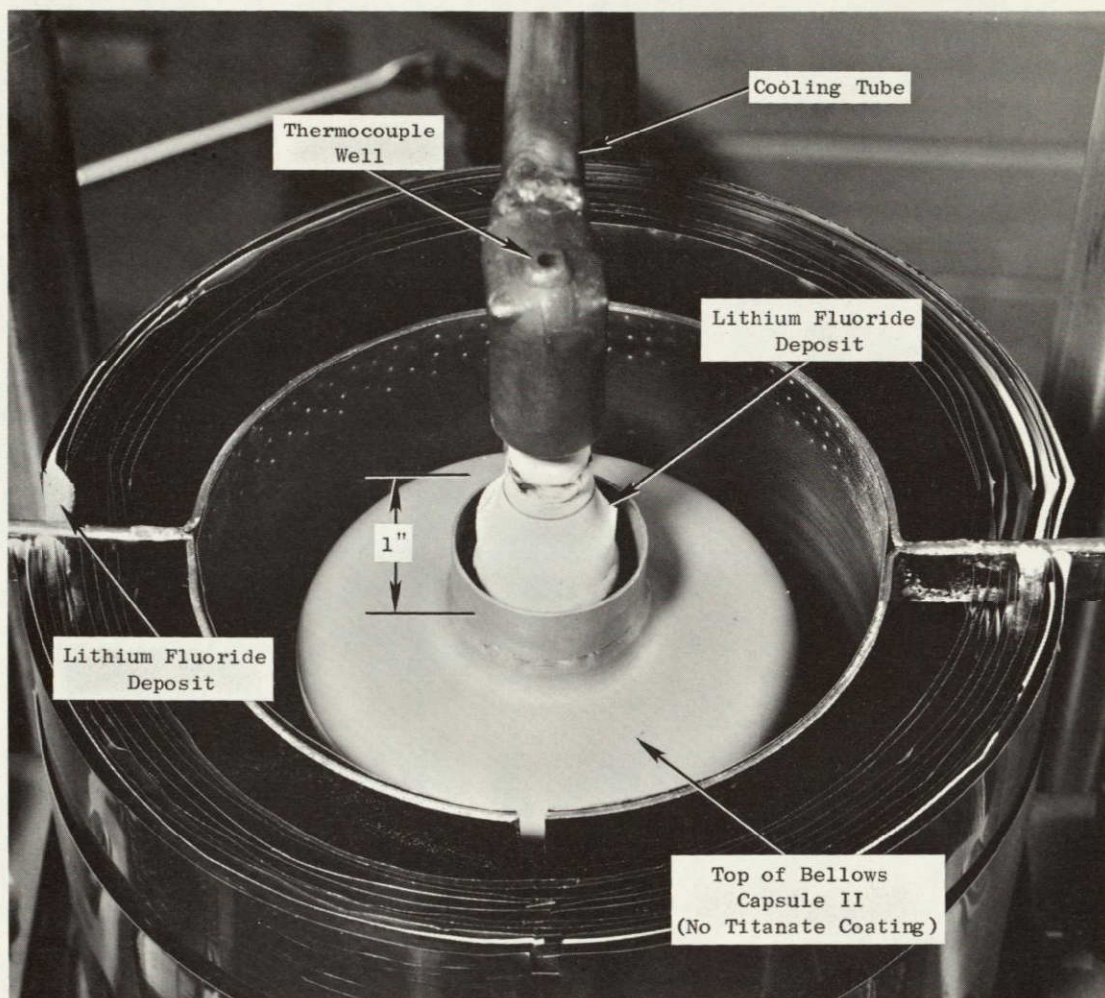
Figure 36. Lithium Fluoride Bellows Capsule II After 3000 Hours of Testing Showing Lithium Fluoride Deposits on Cooling Tube and Tantalum Shielding. (C68031821)

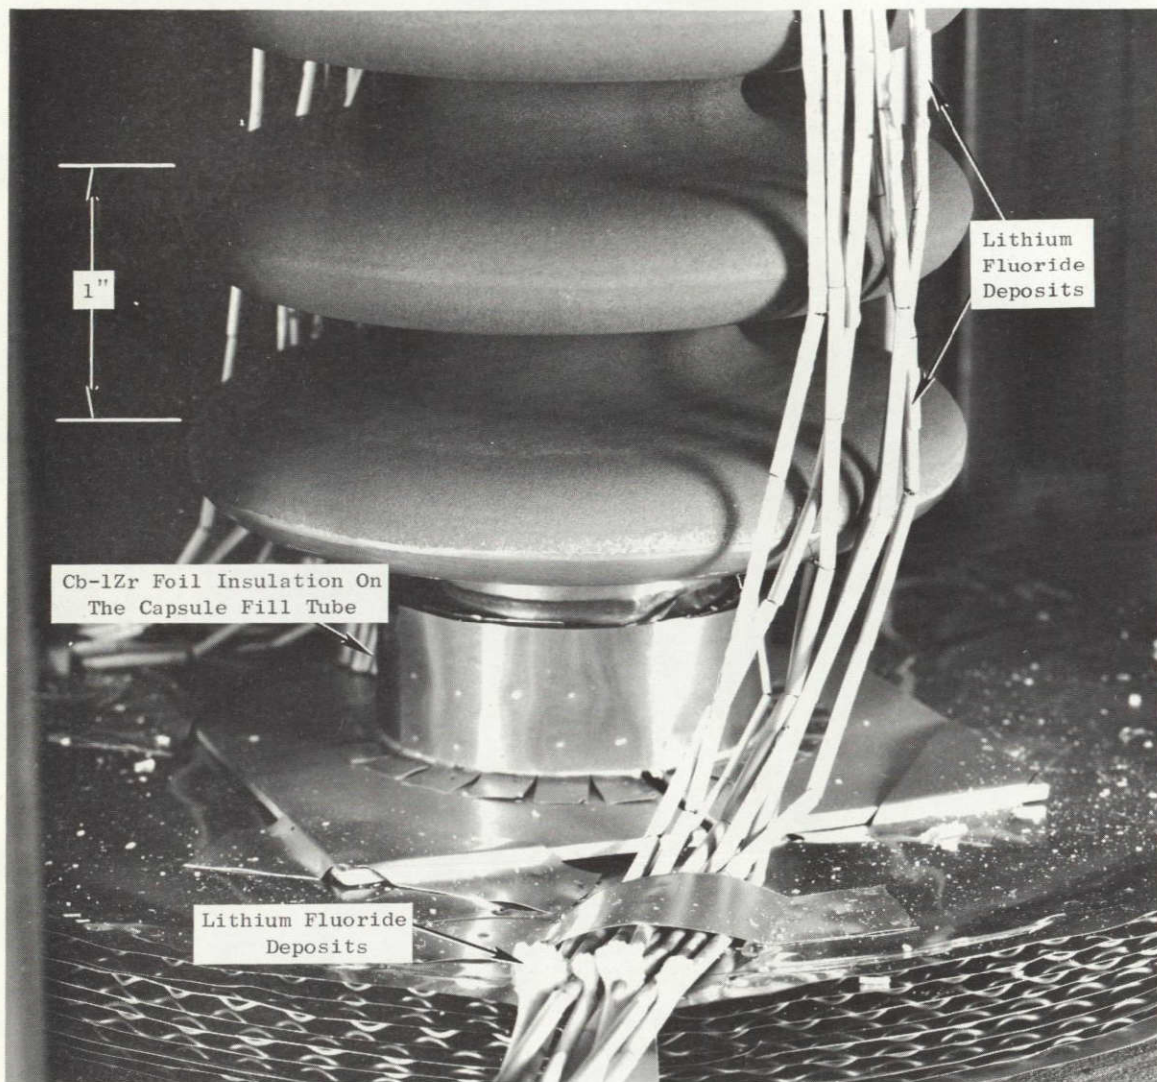
Figure 37. Lithium Fluoride Bellows Capsule II After 3000 Hours of Testing Showing Lithium Fluoride Deposits on Thermocouple Insulators. (C68031820)

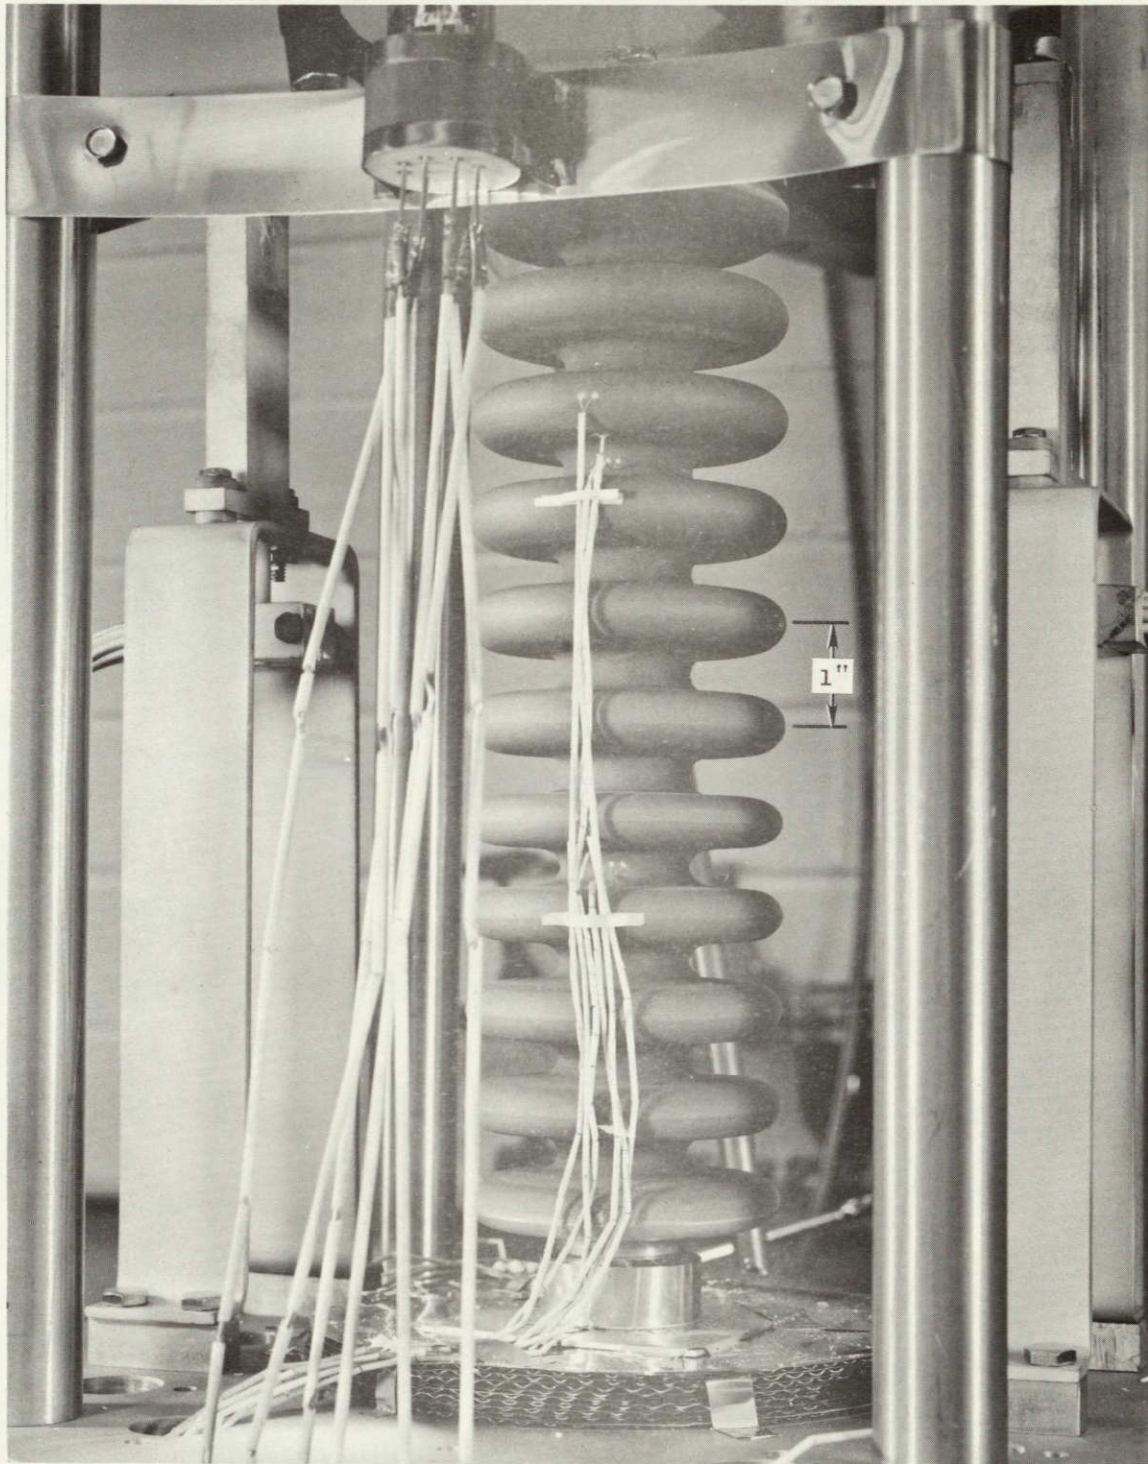
Figure 38. Lithium Fluoride Bellows Capsule II After 3000 Hours of Testing. (C68031822)

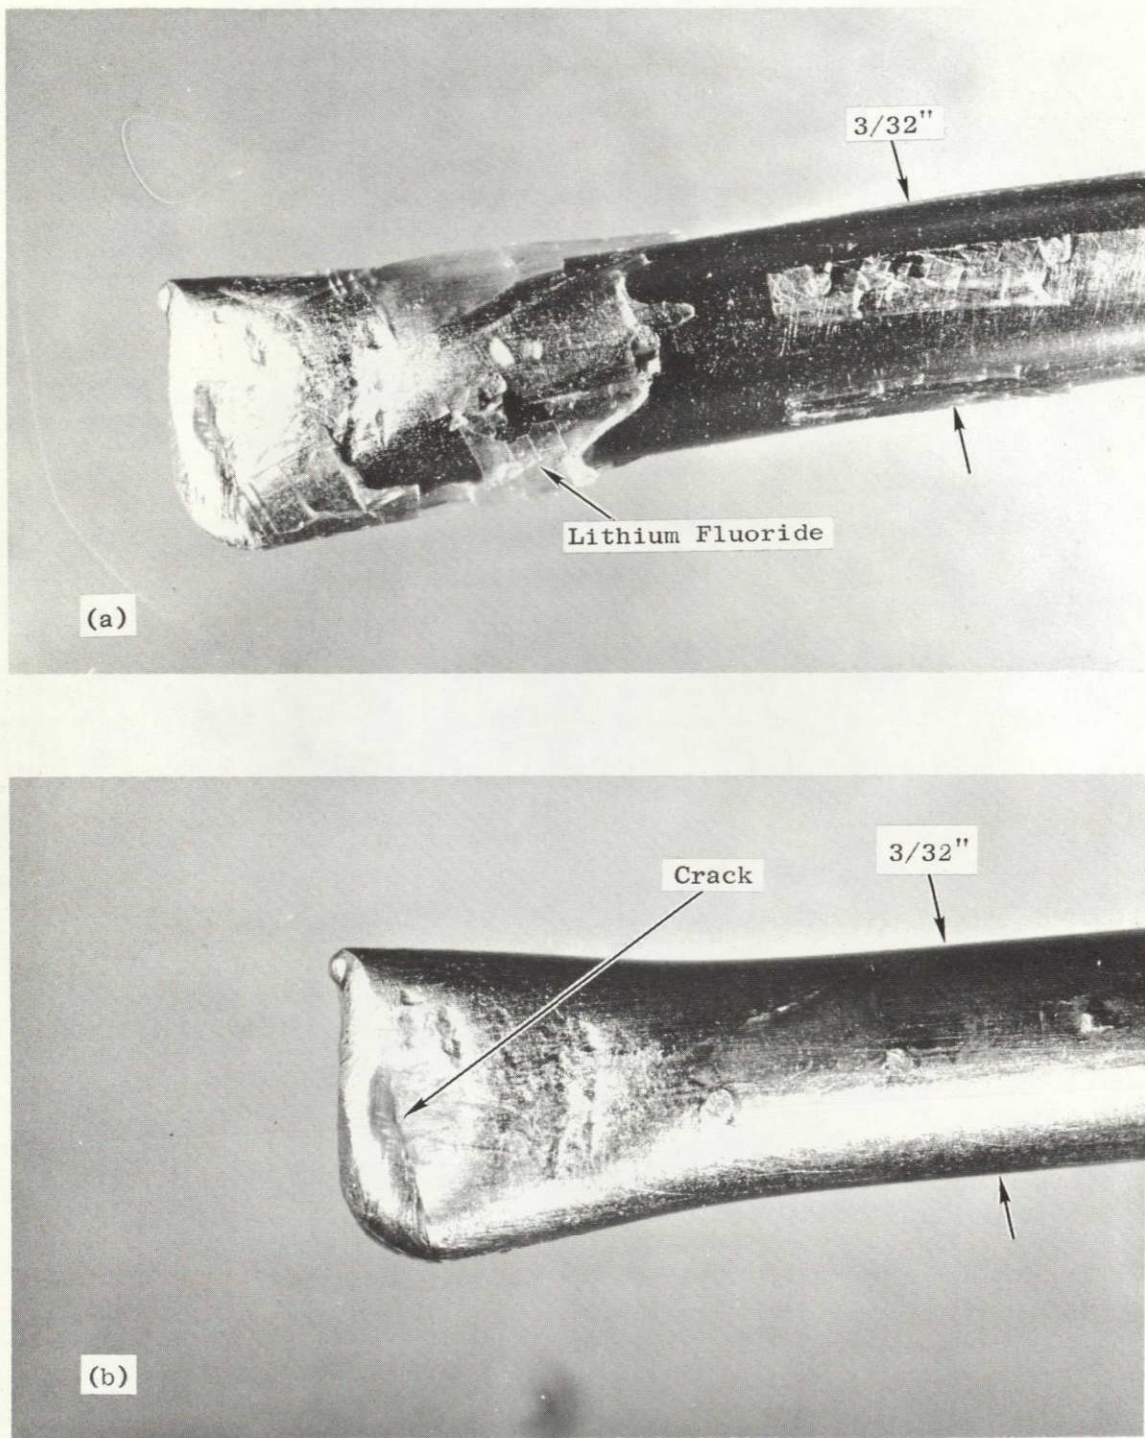
Figure 39. Lower Fill Tube of Bellows Capsule II After Completion of 3000 Hour Test Before (a) and Following Removal (b) of the Lithium Fluoride. Leakage of Lithium Fluoride Occurred at the Indicated Crack. (a) C68031983 & (b) C69031926

Removal of the tantalum shielding on the lower fill tube revealed a glassy transparent deposit of solidified lithium fluoride. This deposit, shown in Figure 39 (a) differed in morphology from the vapor deposits previously shown and is indicative of solidified liquid lithium fluoride. The suspect tube was cleaned of lithium fluoride, and upon closer inspection, was found to be cracked in the weld area as shown in Figure 39 (b). The fill tube was cut from the capsule and cleaned of

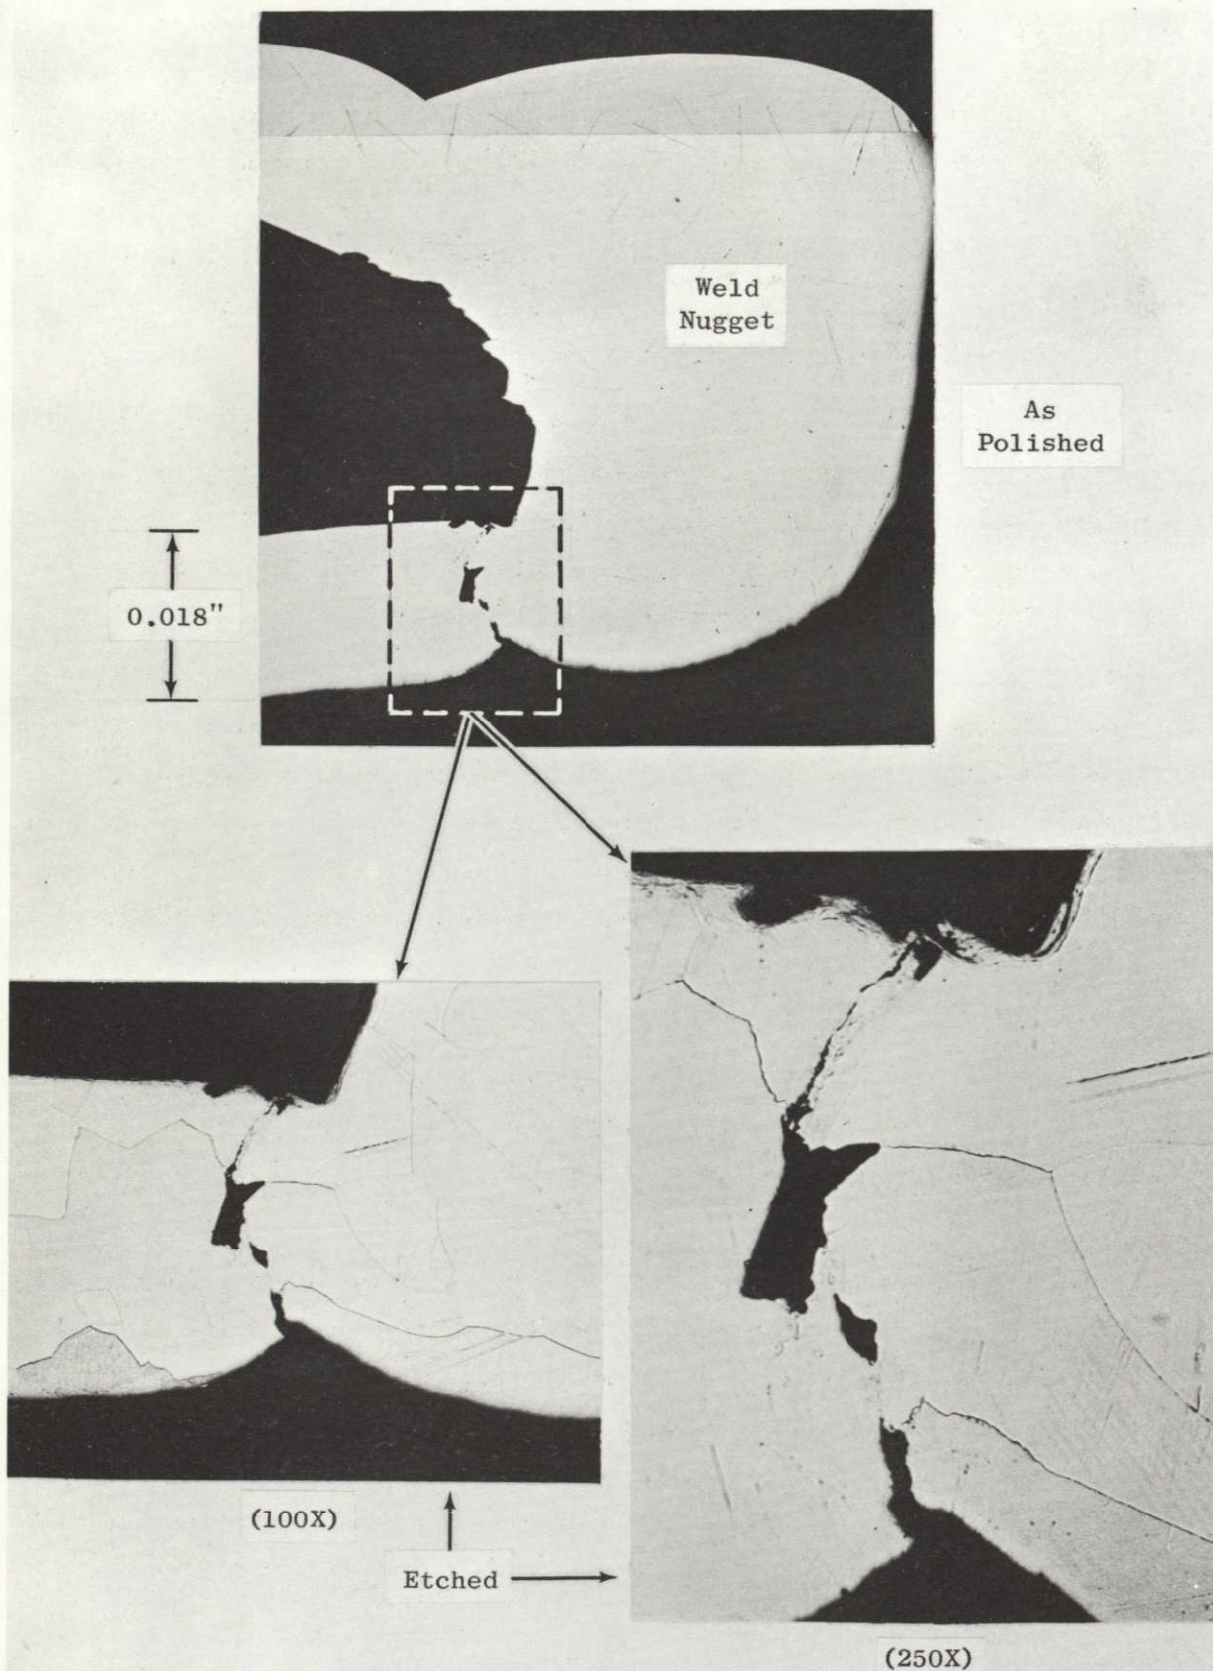
Figure 40. Photomicrographs of the Crack in the Lower Fill Tube Which Caused Lithium Fluoride to Leak from Bellows Capsule II. (F650115)
 (F650112)
 Etchant: 60 Glycerine, 20HNO₃, 20HF (F650114)

lithium fluoride by boiling water. Subsequent helium mass spectrometric leak checking revealed the crack to be the source of the leak. Photomicrographs of the cracked area are shown in Figure 40. The crack is in the heat affected zone adjacent to the nugget of the closure weld. The appearance of the matrix adjacent to the crack and at the ID suggests the Cb-1Zr reacted with lithium fluoride present in this region during welding.

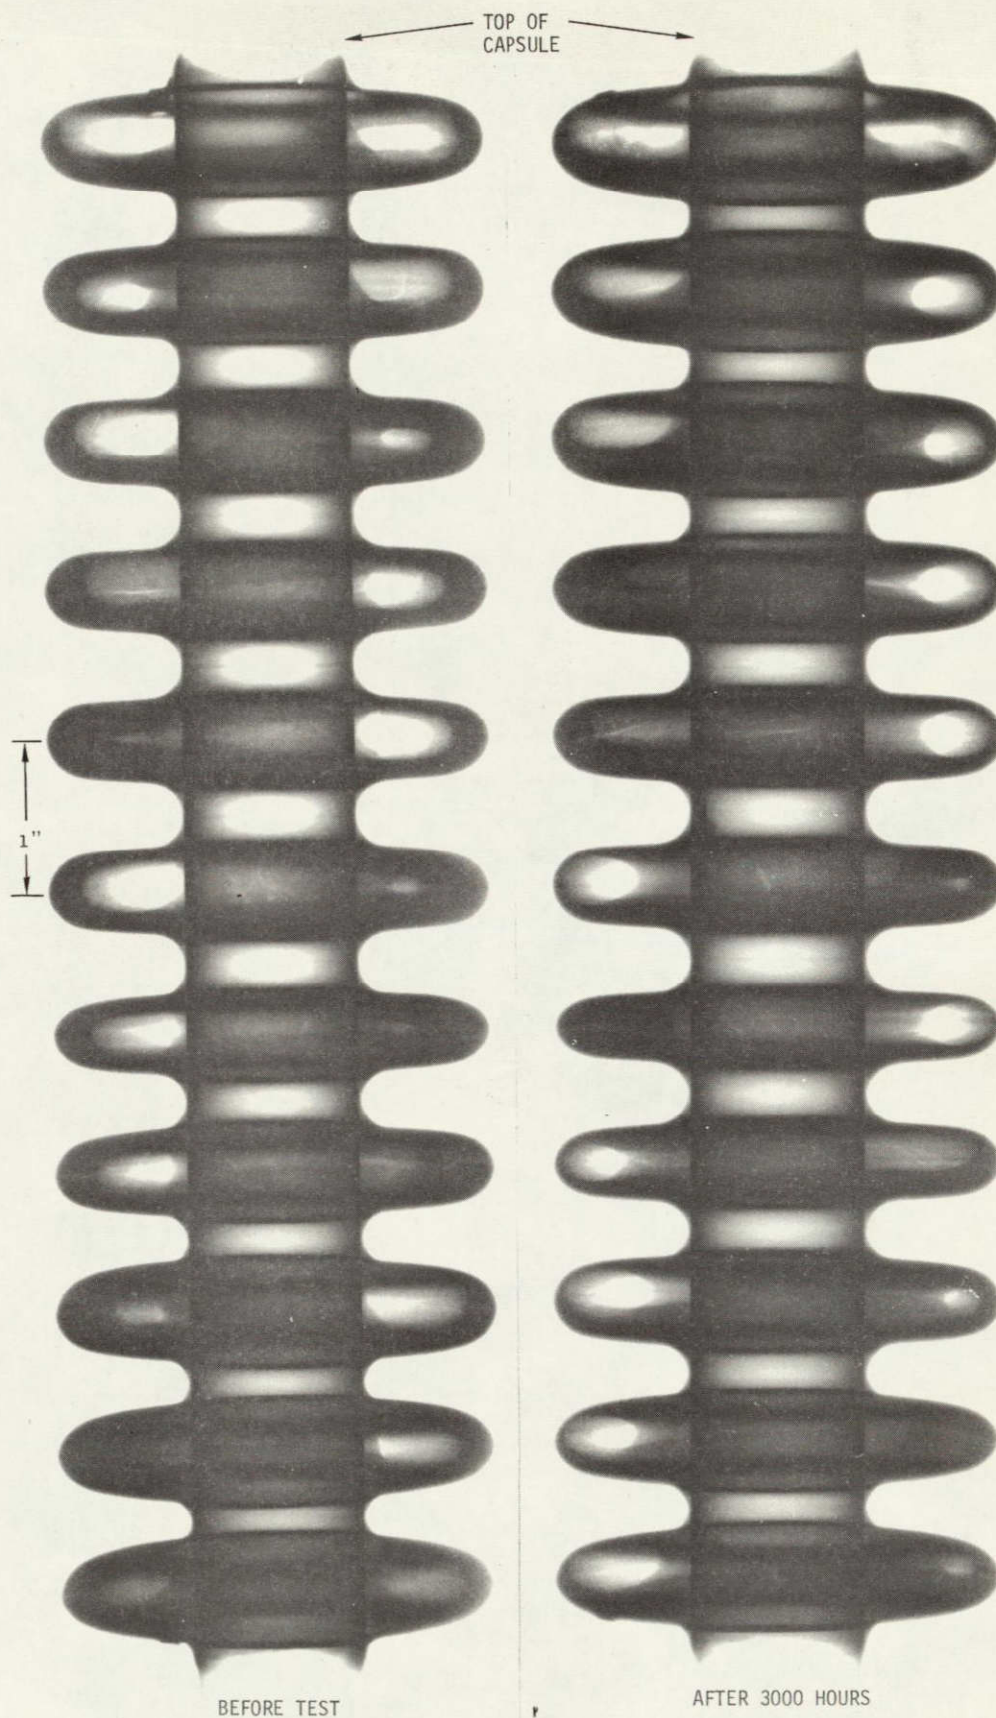
Figure 41. Radiographs of Lithium Fluoride Filled Bellows Capsule II Before and After 3000 Hours of Testing. White Areas are Voids in the Lithium Fluoride.

After the capsule was removed from the test facility, it was weighed revealing 4.5 grams or only 0.3% by weight of the lithium fluoride originally in the capsule had leaked out. Any loss in lithium fluoride volume is not readily discernable by comparison of radiographs of the capsule before and after test as shown in Figure 41.

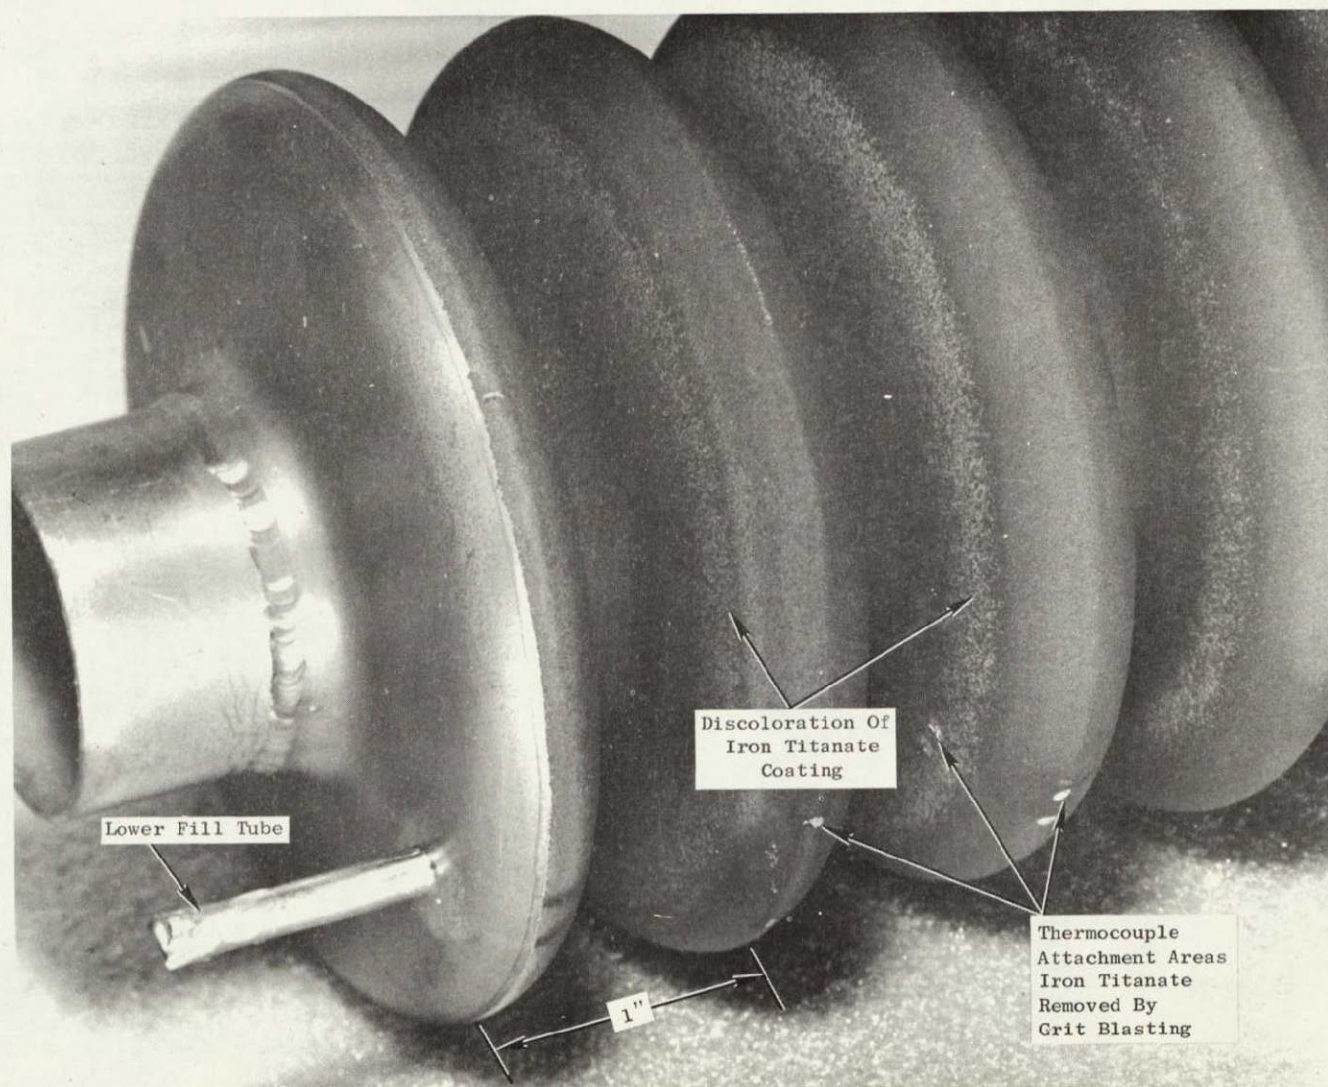
Figure 42. Bellows Capsule II After 3000 Hours of Test Showing Discoloration of the Iron-Titanate Coating. (CDC10984)

Examination of the iron titanate coating on Bellows Capsule II after 3000 hours of testing indicated significant changes in appearance as can be seen in Figure 42.

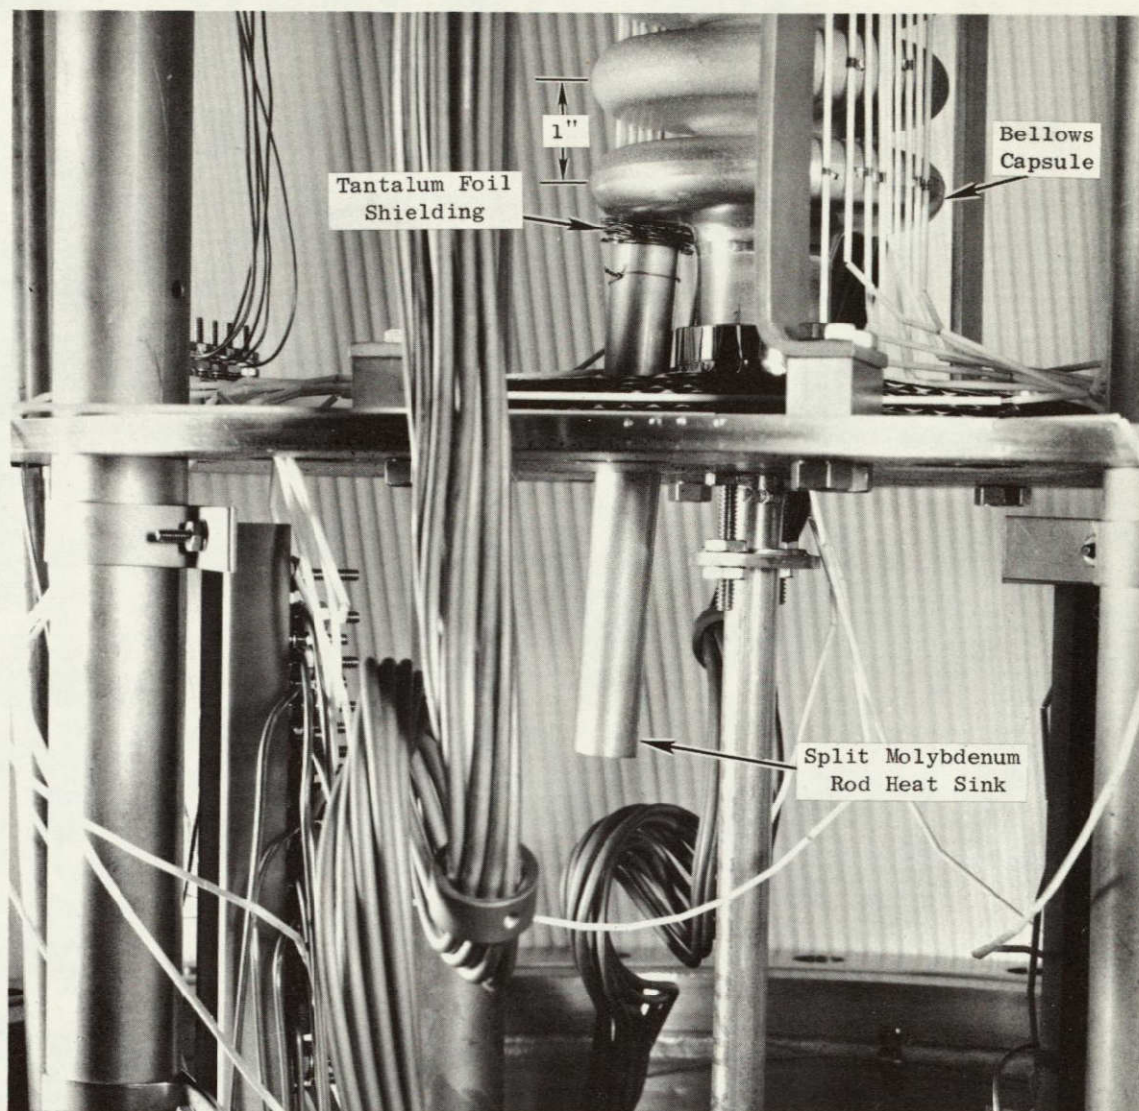
Figure 43. Lower Portion of the Lithium Fluoride Bellows Capsule III Test Facility Showing the Molybdenum Heat Sink Installed on the Fill Tube. (P69-1-27C)

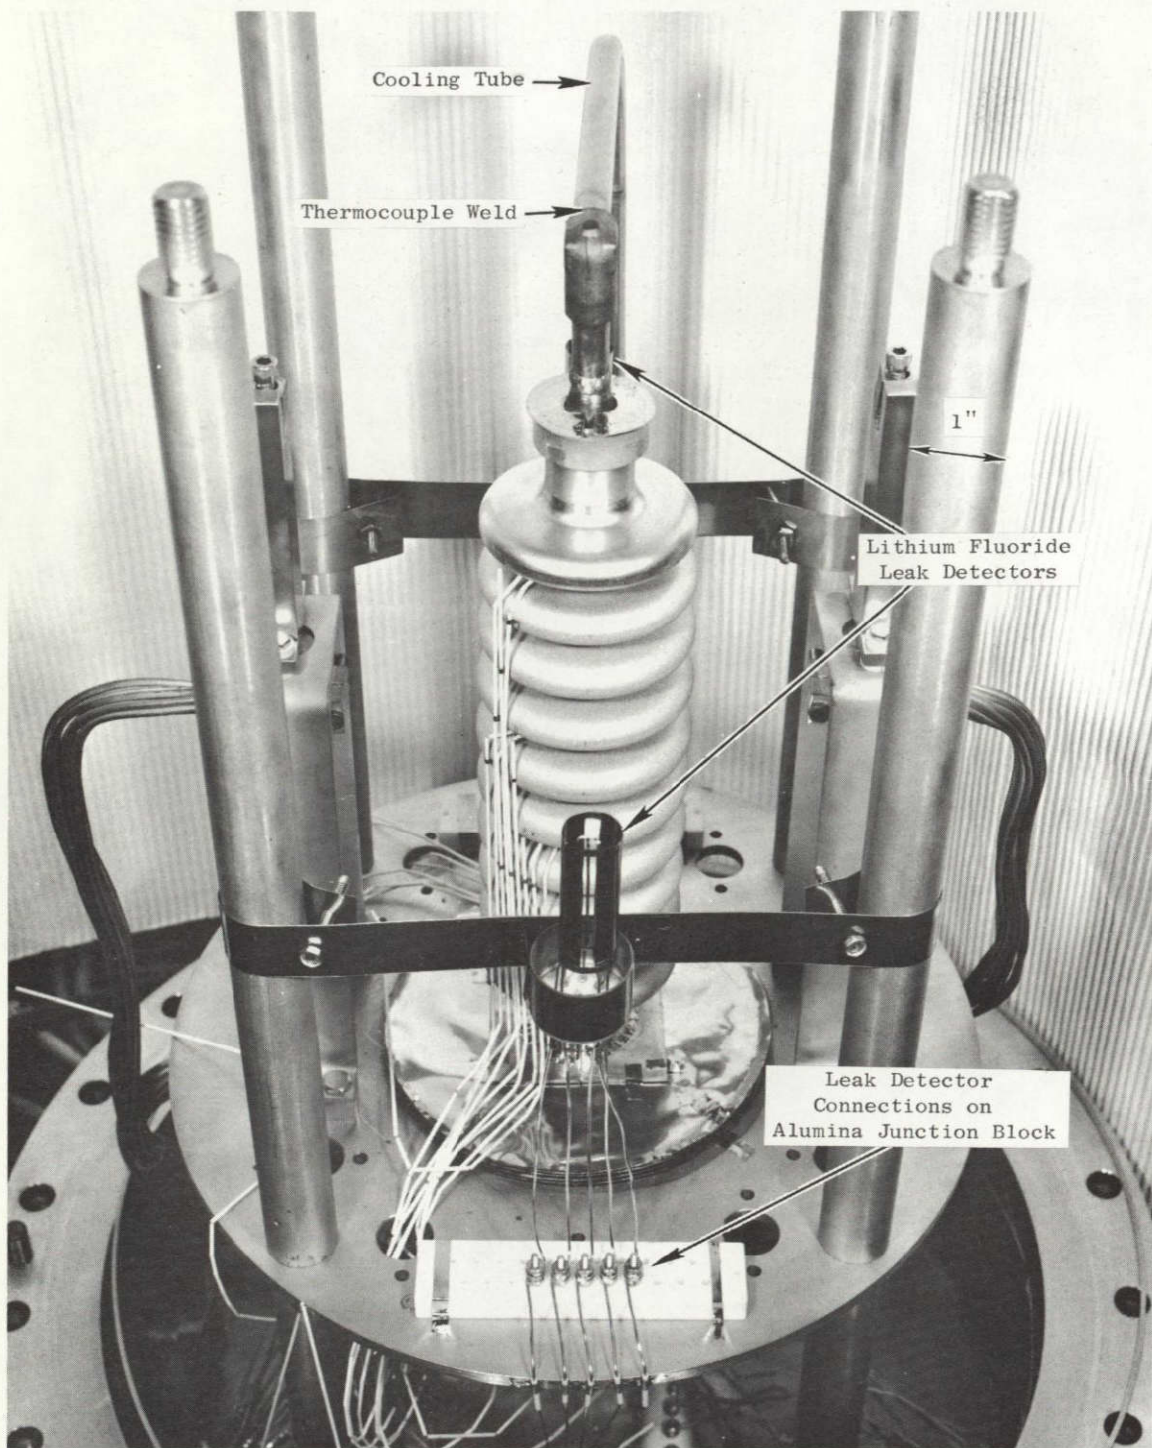
Figure 44. Lithium Fluoride Bellows Capsule III Test Facility.
(P69-1-27A)
